Metallurgical Examination of a Failed AH-64D Pilot Cyclic Stick (Part Number 7-511512001-3)

ARL-TR-3272

August 2004

**Victor Champagne and Scott Grendahl
Weapons and Materials Research Directorate, ARL**

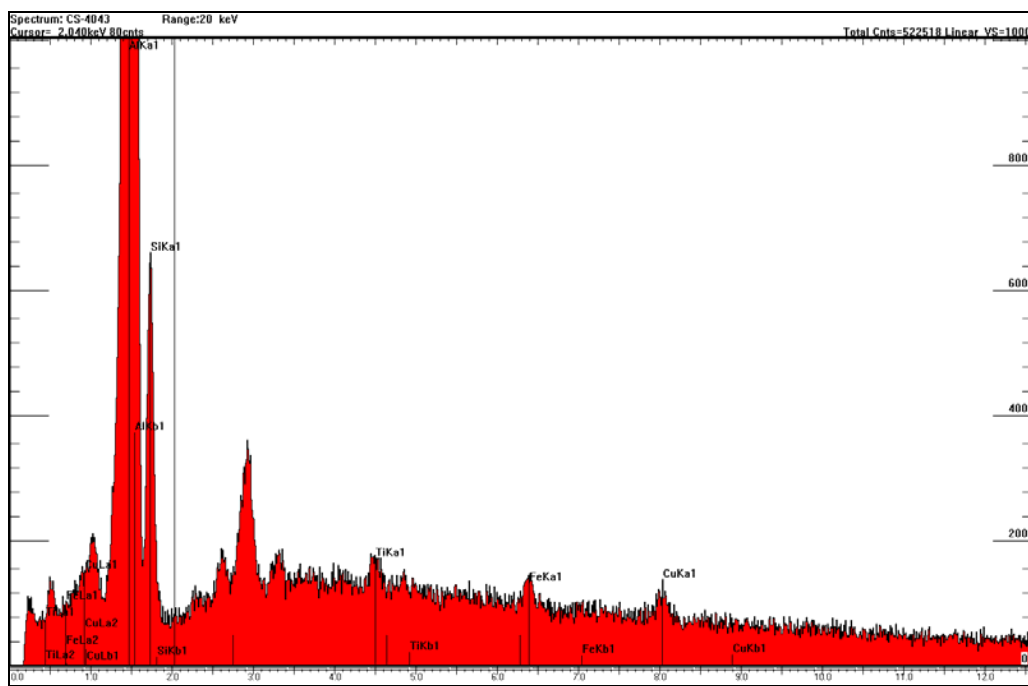
The chemical composition of the weld bead was initially determined by quantitative energy dispersing spectroscopy (EDS), within the scanning electron microscope. This method was chosen to obtain relative chemical composition quickly in lieu of wet chemistry techniques to verify the weld rod material. It was not meant to provide absolute values of chemical composition. The differences in the silicon and copper content between the two welding rods were the distinguishing elements used as a basis for comparison. The small concentrations of manganese, magnesium, and zinc did not yield an appreciable peak and therefore did not factor into the overall weight-percentage calculation. Samples of the two possible weld rod materials, AMS 4190 (ER4043) and AMS 4189 (ER4643), were obtained and analyzed to calibrate the EDS system. The spectra obtained are shown in figures 20 and 21. A section of the weld bead on the elbow fitting was polished with 15- μ m diamond paste, to remove surface contamination, in preparation for EDS analysis. The spectrum of the weld bead compared favorably to that of ER4643, as figure 22 reveals. Table 5 lists the corresponding numerical values of these EDS analyses.

Figure 20. EDS spectrum for the 4043 welding filler rod.

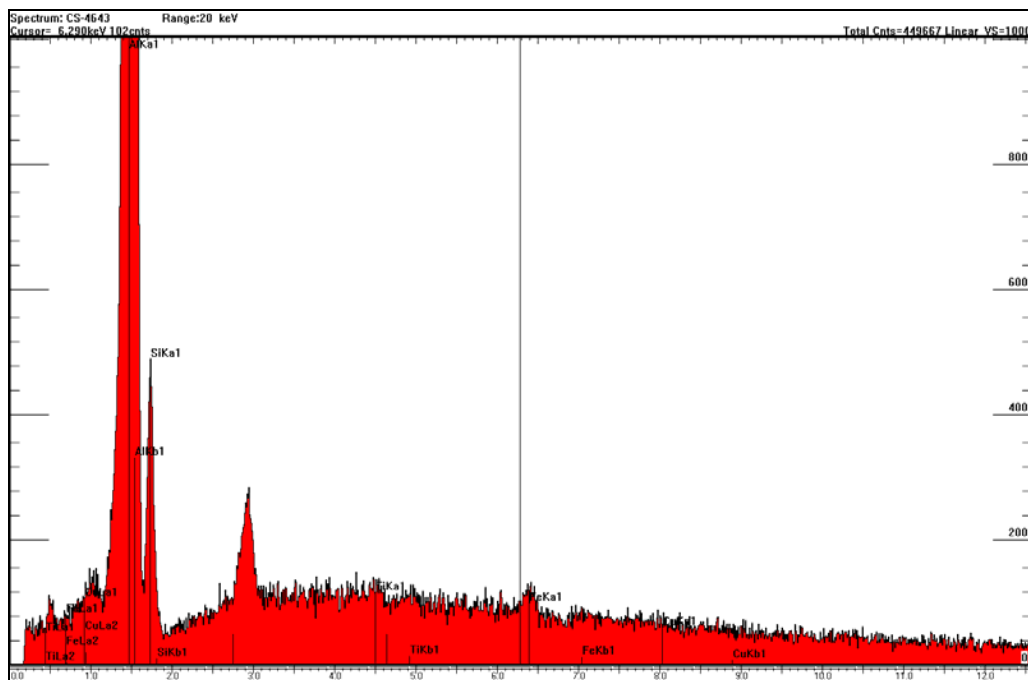
Because it appeared from the hardness data that the pilot stick assembly was not heat-treated, and heat-treatable 4643 weld filler rod was used, a small amount of filler material was painstakingly removed for wet chemical analysis. DC plasma emission spectroscopy (DCP) was used, and the major constituents compared favorably with 4643 filler rod (silicon, copper, and magnesium), confirming the initial analysis. These data are presented in table 6.

Figure 21. EDS spectrum for the 4643 welding filler rod.
